Solid Waste Division...24

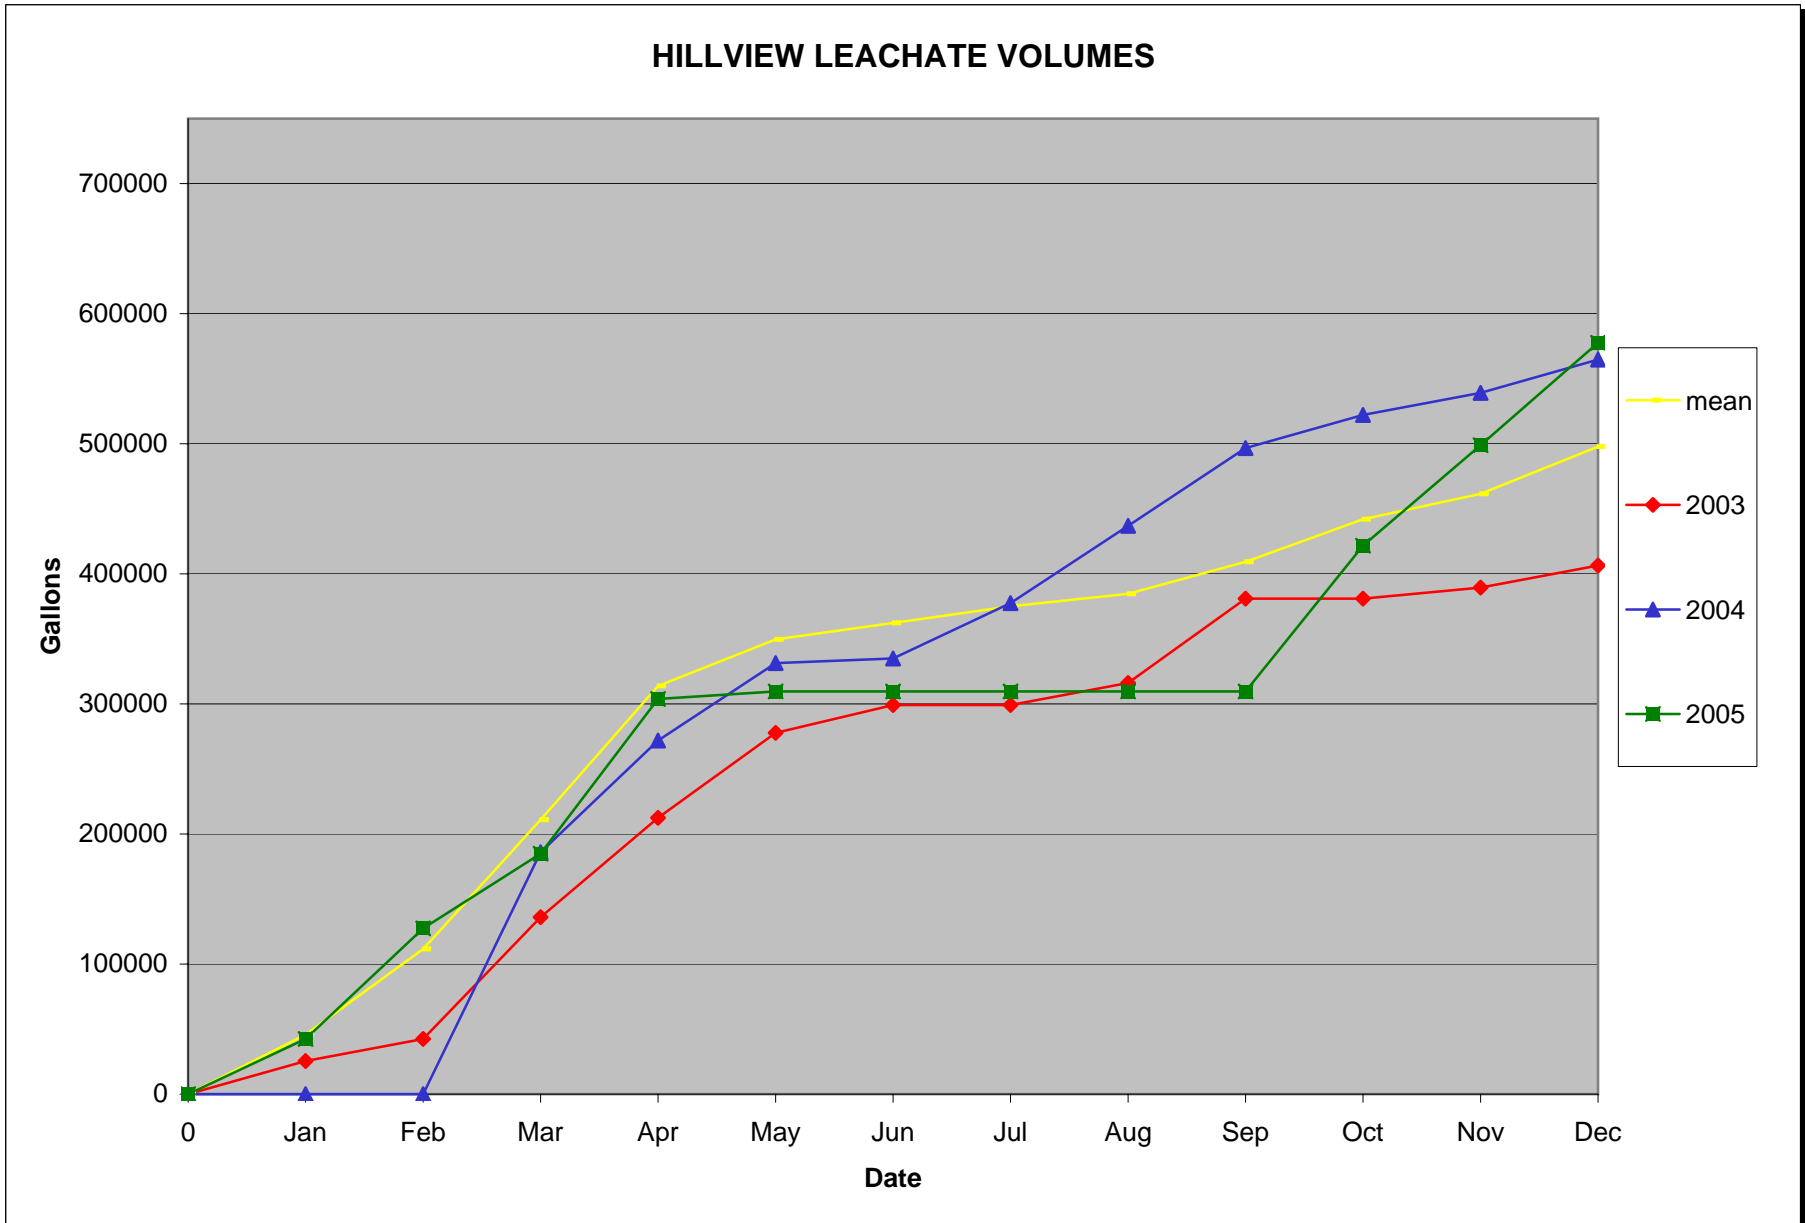
Figure 2: Historical leachate quantities collected at the Hillview Road Landfill.
